Technical Service Bulletin

55 Power rear lid not closing fully, rear lid lock not engaging secondary latch position, DTC B113E29, B12E015, B113E07

55 21 60 2064476/2 September 30, 2021. Supersedes Technical Service Bulletin Group 55 number 21-59 dated September 10, 2021 for reasons listed below.

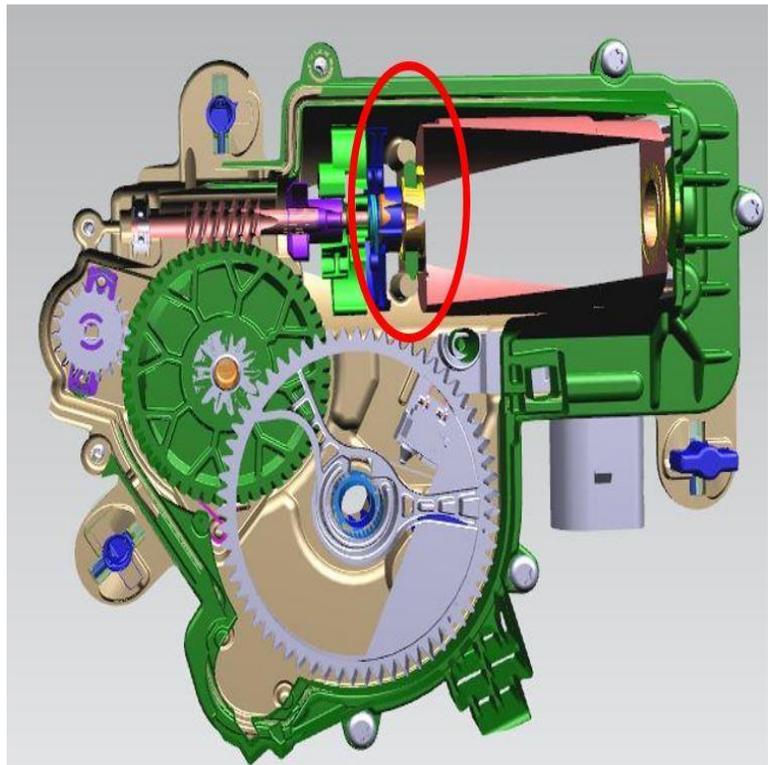
1. The internal clutch of the closing assist motor can be blocked due to a dimensional deviation. This failure mode could cause DTC B113E07 to store (Figure 1).

Figure 1. Blocked clutch due to a dimensional deviation.

Replace the rear lid closing assist motor according to the Elsa Repair Manual.

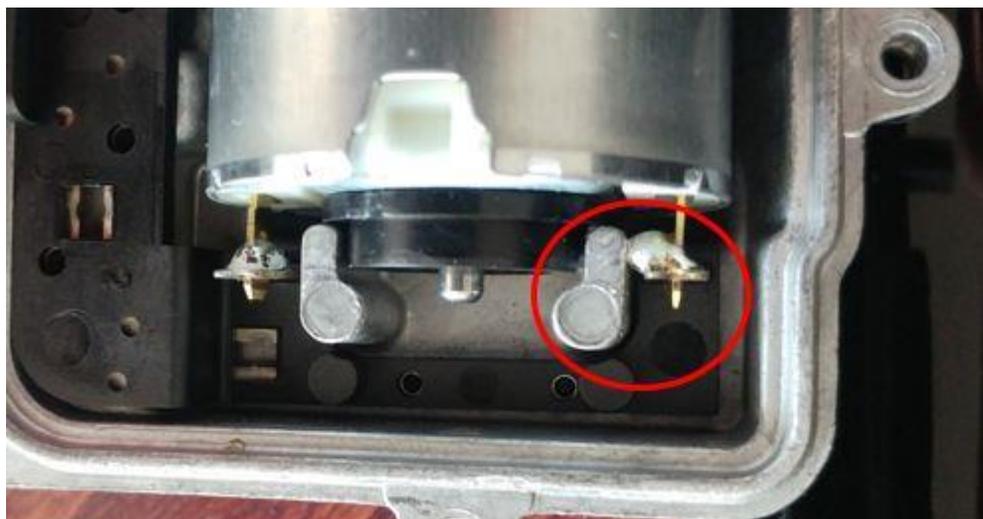
2. An improper solder joint inside the closing assist motor can cause a short circuit. This failure mode could cause DTC B12E015 to store (Figure 2).

Figure 2. Short circuit caused by solder joint.

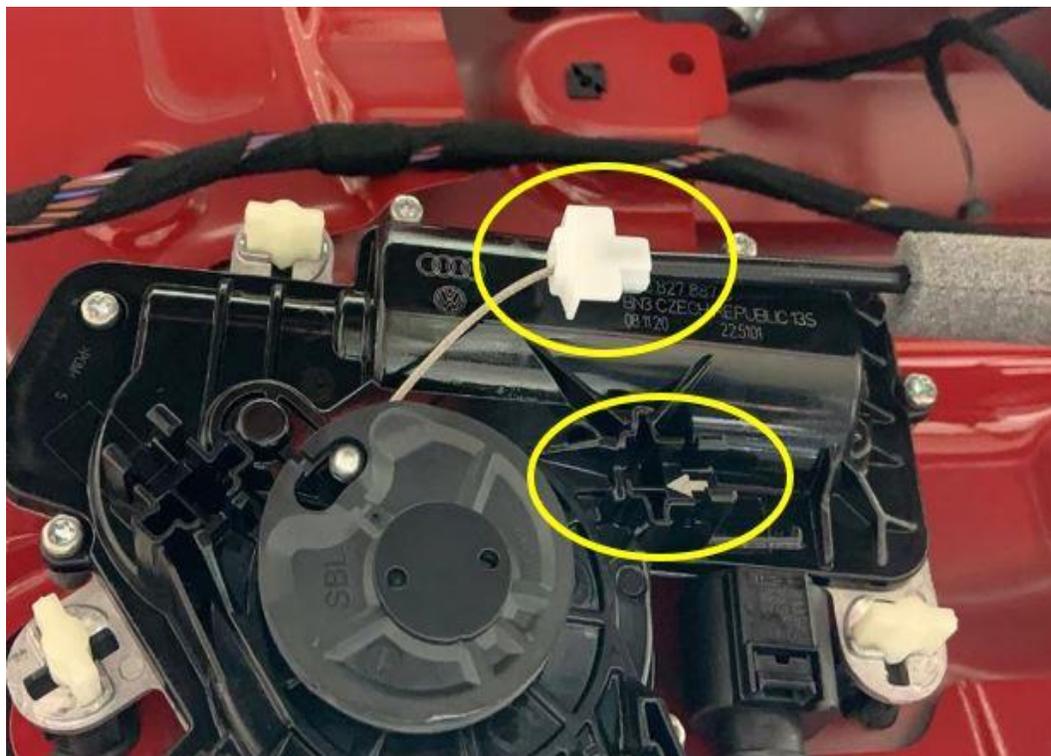
3. The Bowden cable clip has detached from the closing assist motor housing. This failure mode could also cause DTC B113E07 to store (Figure 3).

Figure 3. Detached Bowden cable clip.
